SECTION 3 : ENGINEERING GEOLOGY

The engineering geological investigation for the pre-feasibility study comprised a site visit between 22nd and 24th January 2003, a study of available information and the interpretation of laboratory tests performed on disturbed samples. No field tests were carried out during this visit.

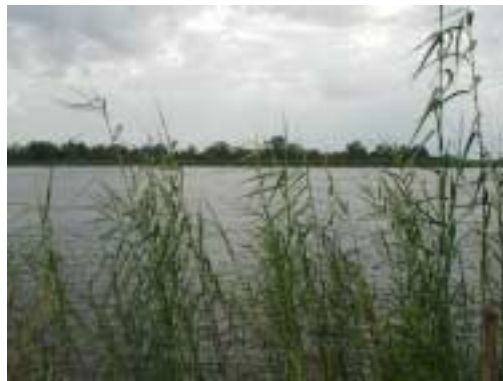
View of Site 2 looking from the right bank towards the left bank.

The valley is also very flat at this site, which has a wide river section (± 400 m). Although no rock was exposed at the time of the inspection, shadows under the water indicated that there was probably bedrock. It can also be assumed that the small island is probably rock with some sediments that have been deposited on its surface which allow the growth of reeds.

Although the Okavango was at low flow during the site visit, no rock outcrops could be seen in the river section other than the dark shadows under the water. The flanks are covered by unconsolidated material, mostly sand and a local resident also confirmed that there were no rock outcrops in the area.

The sandstone/quartzitic sandstone is covered by unconsolidated material. The depth to moderately weathered bedrock is, however, unknown. Comments on founding conditions can only be made after more detailed studies and investigations such as drilling and geophysical surveys are carried out.

after a geophysical survey and drilling have been done. Further investigative work at this site will include the excavation of deep test pits, seismic refraction surveys and the drilling of rotary core boreholes to determine the depth and quality of bedrock.

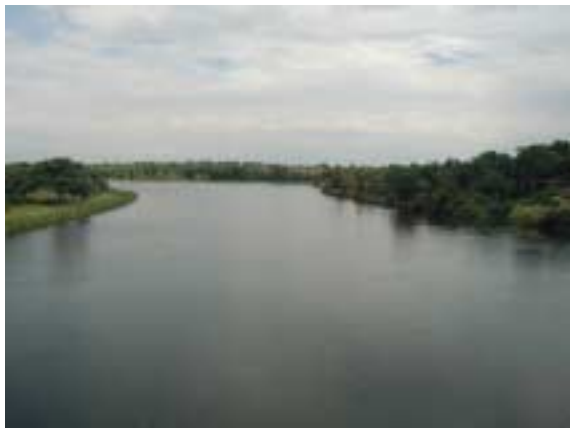
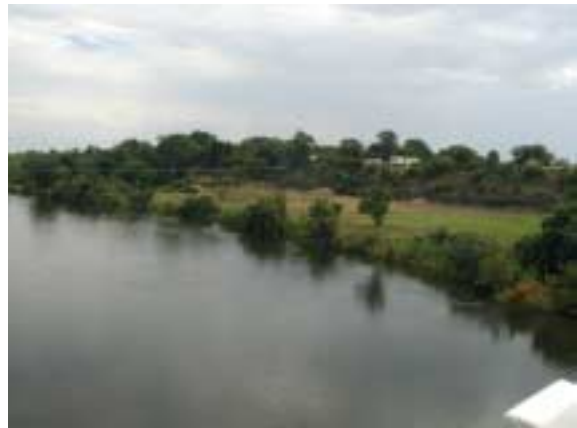
View looking upstream from the Divundu Bridge towards Site 3 : Left photo shows both river banks and the right photo is a view on to the steep left bank

The left bank is steep and rock is visible on the surface whilst the right bank is very flat. Rock outcrops are abundant in the riverbed and also on the right bank. The rock is overlain by white, loose sand and alluvium. The visible rock is very fissured with many cavities indicating a high degree of weathering. The degree of weathering is, however, not worse than that found on the other sites visited, where rock was encountered.

The concrete section of the weir structure can be founded on the sandstone/quartzitic sandstone rock. The rock can be described as light grey to black, medium to highly weathered, highly fractured, medium grained quartzitic sandstone.

Numerous rock outcrops are visible on the flanks and in the river bed. The sandstone rock outcrop will serve as a good founding medium for a small weir structure. The fact that the rock is fractured and that numerous cavities are present indicates that some form of foundation preparation such as grouting may be required.

The upper layer of weathered rock will need to be removed before an adequate founding horizon will be exposed. On the left flank, however, a detailed investigation will need to be carried out to establish the condition of the rock into which an embankment would have to be tied.

The envisaged dam structure is relatively low and will exert low loads on the founding horizon. The upper loose and fractured material must be removed before placement of the foundations can be undertaken.

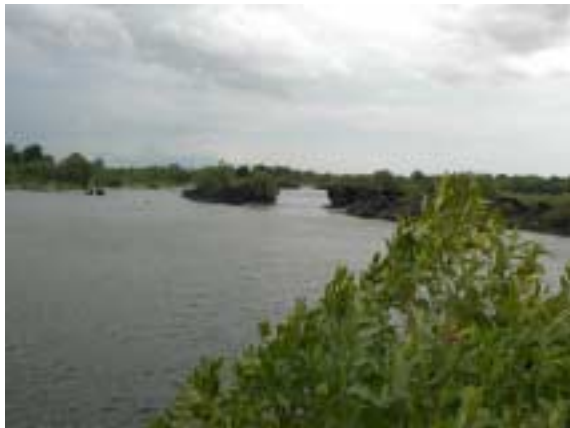
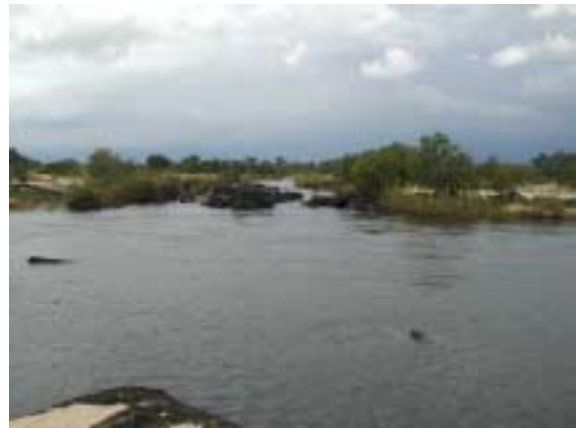
Photographs of Site 4 looking upstream (left photo) and downstream (right photo) showing rock outcrops

The right bank of Site 4 rises gradually, necessitating a longer embankment than on the left bank, which rises rapidly from the riverbed. On the left there is a hill which rises rapidly from riverbed level. However, there is a side channel which passes around the northern side of the hill which can be utilised, in the first instance, as a diversion channel during construction. After the weir in the main river course has been completed, the valley will be closed with an auxiliary embankment incorporating a fuse plug which would breach when a flood occurs with an intensity greater than the design flood.

From the visual inspection held at the time of the field inspections it would seem as though founding conditions would be good, relative to the low bearing pressures to be expected below the weir. The weathering pattern is generally the same as on the other sites, which would require removal of the loose soft rock and severely fractured sections near the surface. It is hoped that, with the removal of rock to founding level of the concrete section, good founding conditions will be found. This will have to be substantiated by core drilling and geophysical surveys before a final decision can be taken.

Rock outcrops are present on both sides. The foundation of the structure can be placed directly on rock. Loose and jointed material will have to be removed. Further investigative work on these sites will include:

- Geophysical surveys such as seismic refraction surveys to determine the depth and quality of bedrock, electromagnetic, magnetic and/or resistivity surveys to determine the type, orientation and conditions of the linear features,
- Rotary core drilling and Lugeon Testing,
- The excavation of deep test pits,
- Sampling of materials and laboratory testing.
