### FOCUS ON FLAMINGOS AND POWER LINES

#### Power line survey: Trekkopje – Wlotzka 132 kV (TRE/WLO 1-186) and the start of the Trekkopje – Henties Bay 66 kV bypass (W1 – W16)

Report by Ann & Mike Scott

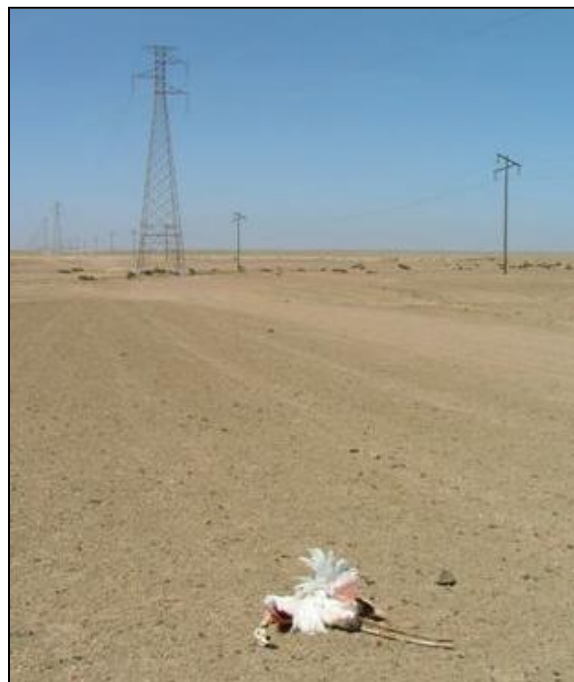
Flamingo mortality on a power line between Swakopmund and Walvis Bay in 2007 (photo Gloudi de Beer)

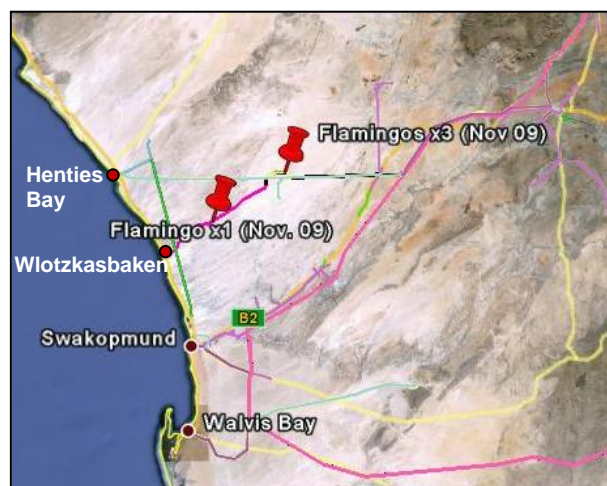
(1) On the 132kV – the flamingo was spotted between Towers [TRE / WLO 136] and [TRE / WLO 139], which

is located between Lichen and Dolorite Sub-station. (2) On the 66kV – the flamingos were reported between the first angled strain tower (W 12) and the intermediate just after the river crossing (W 16).

Google image showing sites of flamingo collisions (red markers) on the new 132 kV Trekkopje-Wlotzka line north-east of Swakopmund (left), and 66 kV Trekkopje Bypass (right) (based on a Google map generated by Alice Jarvis [EIS]).

1. **Mitigation:** Investigate mitigation in problem areas already identified in this report. The Mace Bird Lite and/or blinking solar powered aviation lights attached to the optic fibre/ground wires could be tested on an experimental basis. Investigate markers that could possibly provide an (ultra-sonic) auditory signal.

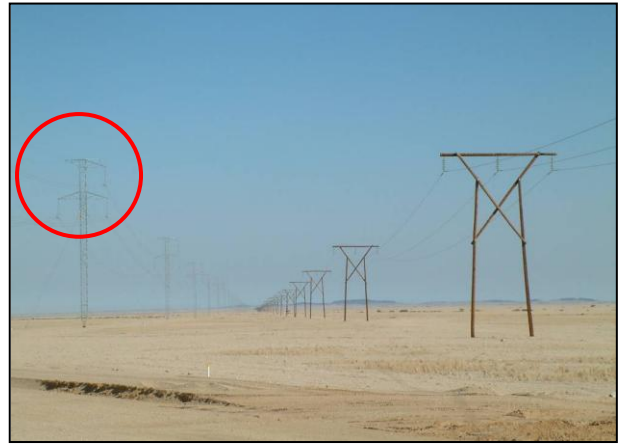
The 66 kV Trekkopje Bypass line (right, with wooden five-pole structures) runs parallel to the larger 220 kV line (left); it is possible that the three flamingos collided with the less visible earth/optic fibre ground wires (red circle above and red arrows below) on the latter structure (photos Ann Scott)

We investigated the line from Tower W1 (S22.13606 E14.89558) to W16 (S22.11880 E14.87559), for about 2.9 km (towers are on average 180m apart). The incident took place between Tower W12 and W16; but possibly on the high, less visible optic fibre ground wire (OPGW) of the adjacent 220 kV line, rather than on the 66 kV line.

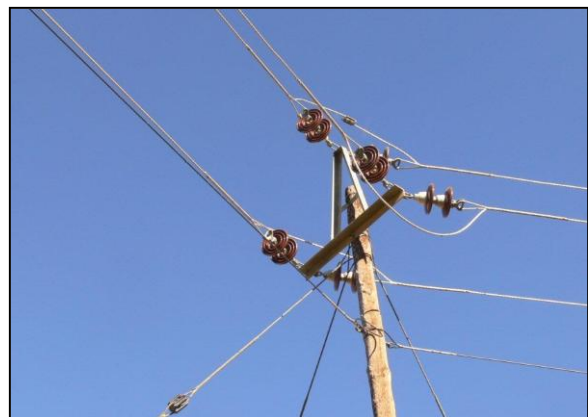
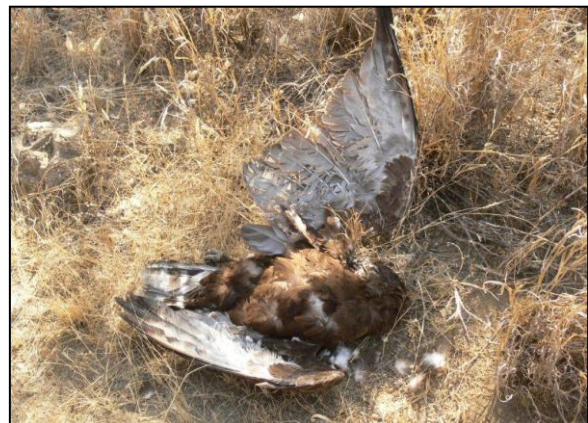
On 8/8/10, Neil and Gudrun found the remains of a Brown Snake-eagle at Gammams Sewage Works, in the north-western part of Windhoek (22 32.095S 17 01.623E; Tower 935). The remains of a large snake were visible in the birds' talons. They assume that the eagle had killed the snake and perched on the pole to eat it and that the snake may have touched a conductor, electrocuting the bird. Both carcasses were about a week old.

- Top: The A-frame pole structure is normally considered 'safe' for perching raptors.
- Centre: The body of the snake may have touched a conductor, electrocuting the bird.
- Bottom: The remains of the snake were still visible in the bird's talons (photos Neil Thomson)

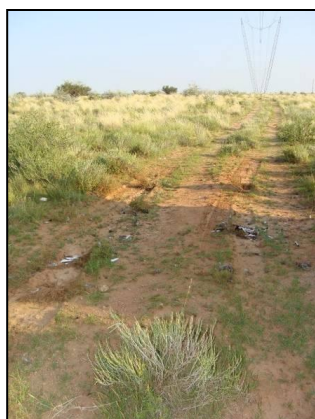
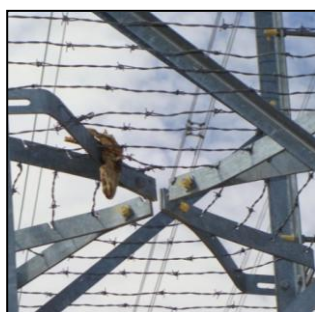
- Bustard x1 (Kori?) – Tower 622
- Bones (vulture?) – Tower 622
- Water bird (heron?) – Tower 463
- Nest of Black-chested Snake-eagle (Tower 622)
- Rock monitor – Tower 461 (probably prey remains)

Top (left) Remains of a bustard.  
 Top (right) Remains of vulture.  
 Bottom (left) Remains of rock monitor.  
 Centre and bottom (right) Black-chested Snake-eagle and nest  
 (Photos AC van Zyl)

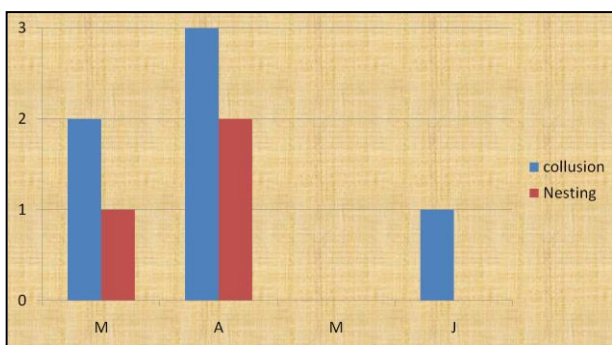
1. Collision and nesting incidents during the study period.

As shown in Figure 1 (above), the highest incident was collision. Most of the victims were small birds. This may mean that small birds are at high risk from collision because they tend to fly in groups. It has also been stated that birds that fly in flocks are at risk from collision because birds at the back cannot see the overhead power lines. Electrocutation on small birds is rare because they have got a short wingspan. This means that they cannot easily bridge the air gap between two live components. The rate of electrocution on large birds of prey depends on the design of the structures and the availability of food in the research area. This means that a high population of e.g. dassies/rock hyrax may lead to increased number of large birds of prey e.g. Black Eagle, which may also result in high electrocution and collision risk.
