**Map Sheet: 1714 Oshakati: Preferred alternative (red) route**

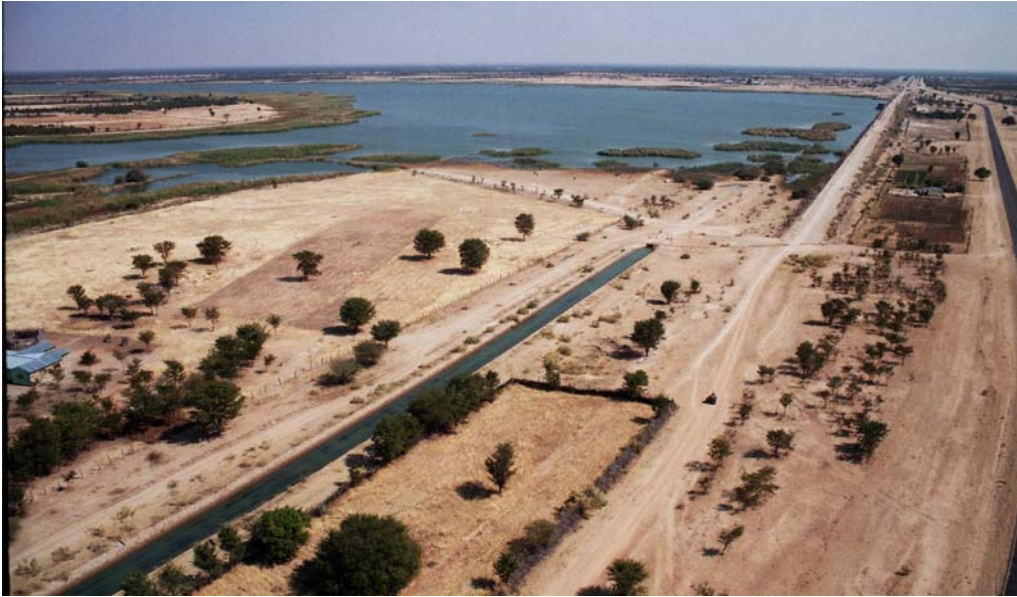
**Photo 27:** Onesi Dam on the south side of the tar road (C46). The width of the dam on the south side of the road is an obstacle for the powerline, which will therefore follow the road on its north side (out of this photo) where the dam is much narrower. Immediately west of the dam the preferred route crosses to the south side of the road again. The areas near the road are highly disturbed even though the density of settlement is low.

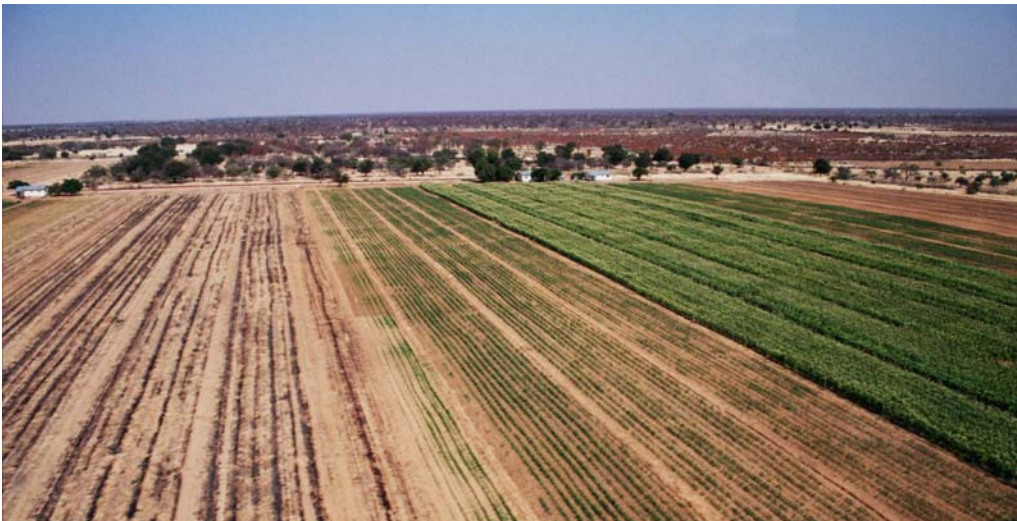
**Photo 28:** West of the dam are these irrigated croplands close to the road. The alignment may therefore need to be either very close to the road, or behind these cultivated lands. Large fruit trees in the background will also need to be considered in determining the exact alignment.
